# Xenarc/Gain 700 Interface daughter board pinout

motherboard manufactured May '04

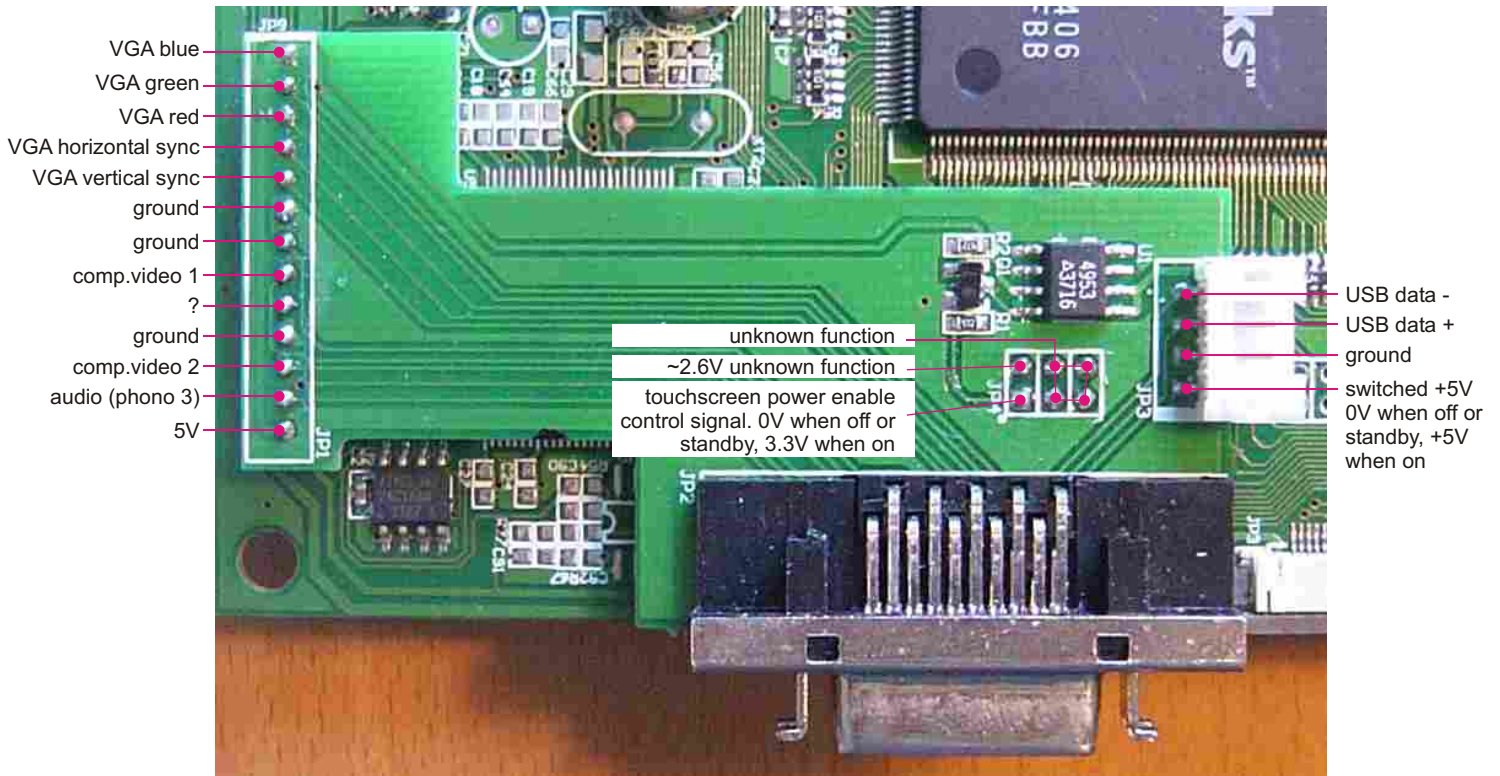
looking at pin side

I currently don't know which grounds are appropriate to which signal. Looking at the PCB, they're not all commoned together at JP1, indicating that they have their own routes on the motherboard. DC continuity test made them all look identical though. I'm concerned getting these wrong may reduce signal integrity.
