Xenarc/Gain 700 Interface daughter board pinout

motherboard manufactured May '04

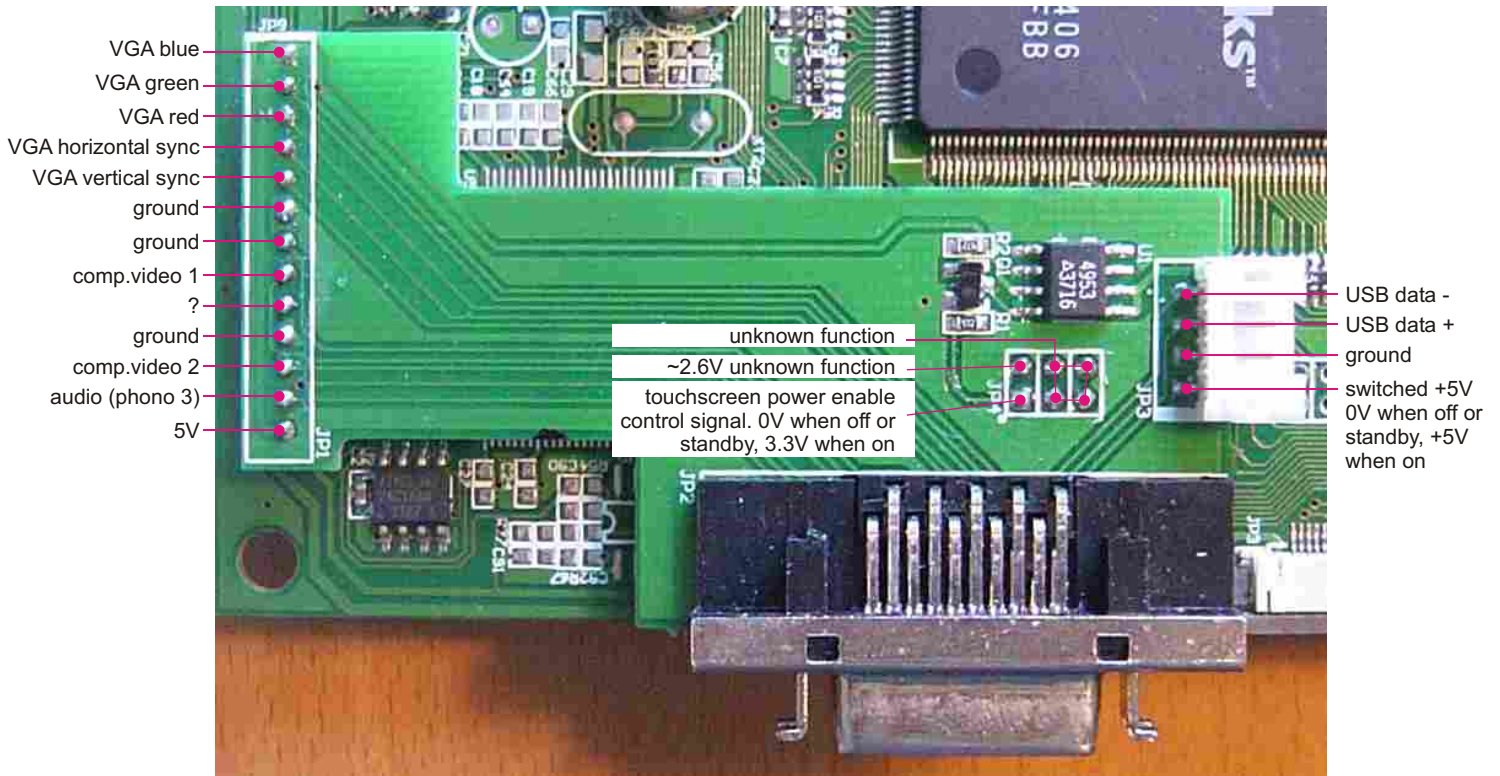
looking at pin side

I currently don't know which grounds are appropriate to which signal. Looking at the PCB, they're not all commoned together at JP1, indicating that they have their own routes on the motherboard. DC continuity test made them all look identical though. I'm concerned getting these wrong may reduce signal integrity.
